# COMBUSTION TURBINE (CT) HOT SECTION COATING LIFE MANAGEMENT

## *Semi Annual Technical Progress Report*

***Agreement Number:*** DE-FC26-01NT41231

R. Viswanathan/D. Gandy  
EPRI

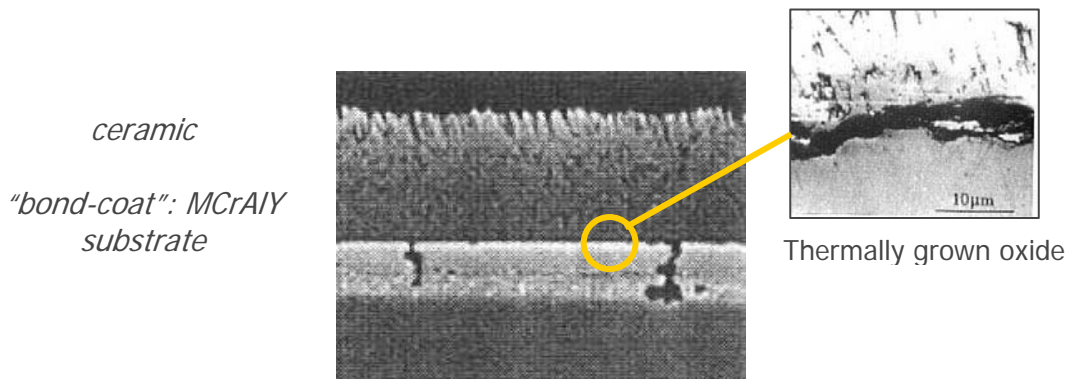
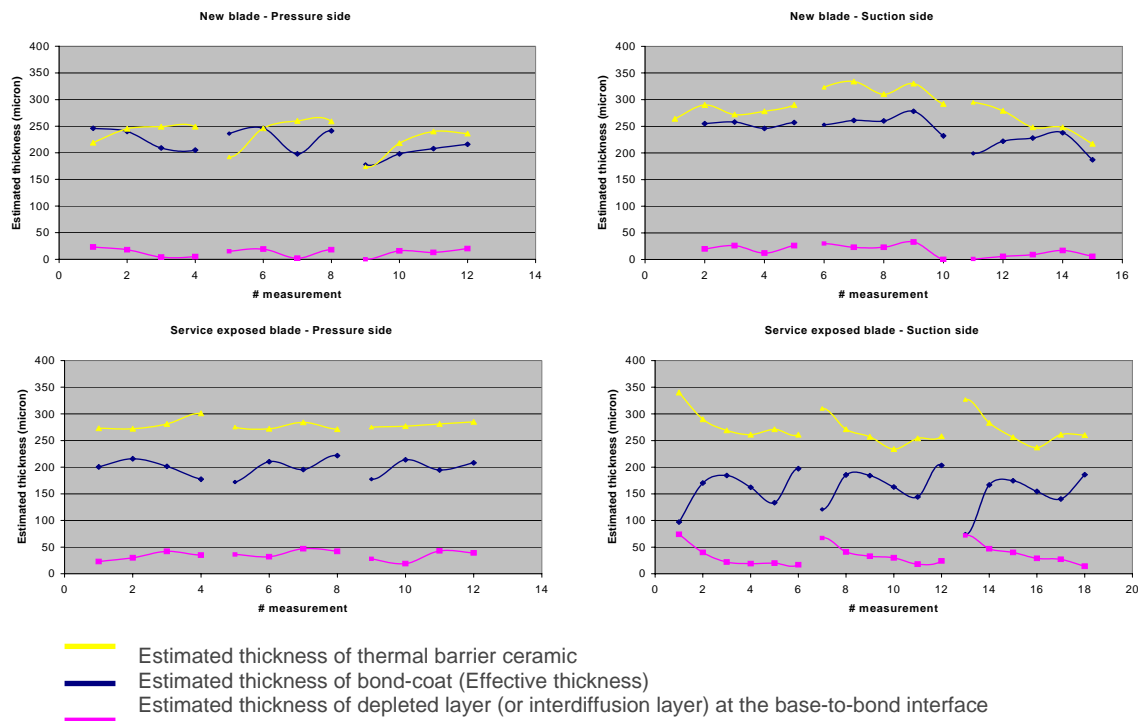
**Figure 6.3: Plotting of Estimated Values of TBC, Bond Coat, and Inter-Diffusion Coating**

Although this graph presentation was made by our equipment manufacturer, CESI, we expect to get similar results when similar testing is conducted during our field trial in October. The bottom two graphs clearly show the effect of TGO causing the TBC thickness to increase while reducing the effective bond coat thickness due to depletion of Aluminum to oxide formation.

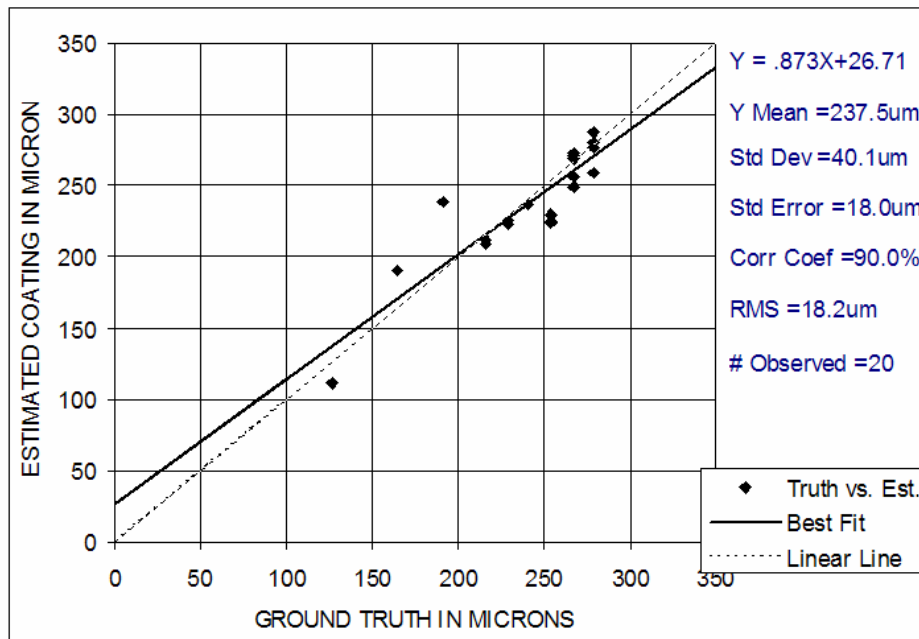
Figure 6.10 shows the regression analysis of comparing the eddy current-based coating thickness estimates to measured coating thickness values in microns. This analysis included 15 data points from bucket #7 and five data points from bucket #57. Even though bucket #57 was more cracked, it gave us needed data points in the lower thickness range. This excellent correlation of 90% with root-mean-square (RMS) error of 18.2 micron was obtained using a 4-layer\_ 6-parameter plane wave analysis. After fixing the top oxide layer value to 0.075 MS/m, the inversion programs estimated the conductivity values of topcoat, bond coat, and substrate along with the coating thickness values of oxide layer, top coat, and bond coat.

**Figure 6.10: 4-Layer\_6-Parameter results with oxide conductivity set at 0.075 MS/m for total coating thickness comparison**

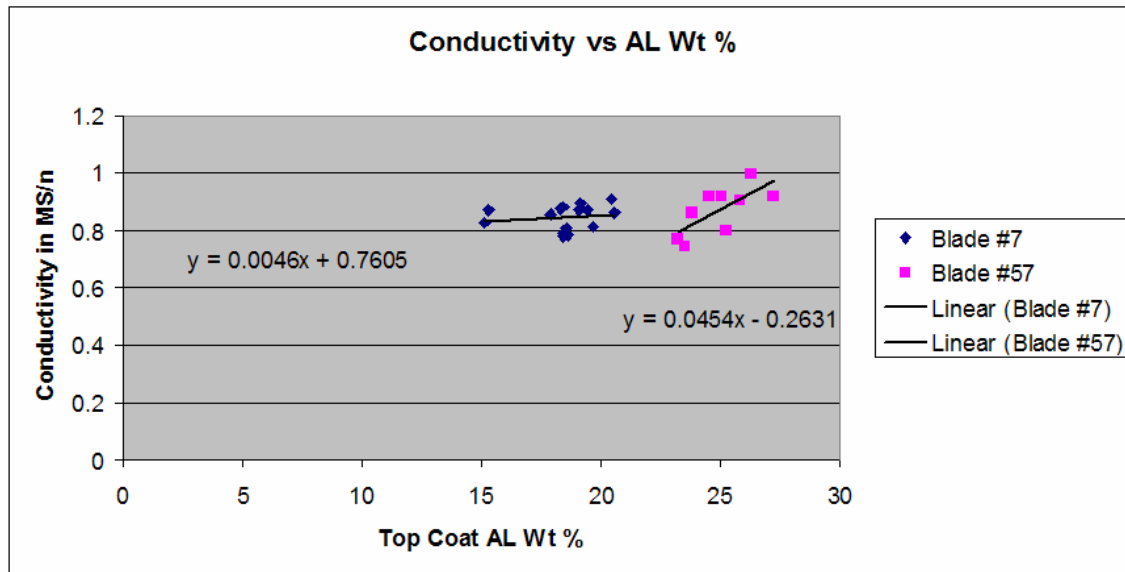
**Figure 6.12: 4-Layer\_6-Parameter results with oxide conductivity set at 0.300 MS/m for comparing conductivity to aluminum weight percent of Buckets #7 and #57**

Although no direct correlation exists between the calculated conductivity values to measured Aluminum weight percent for both buckets #7 and #57, two separate groupings were shown. It was encouraging that within a group, some correlation was noticeable, especially for bucket # 57 with correlation coefficient of 72%. For bucket #7, the correlation was down to 17%. The Y mean values were 0.871 MS/m for bucket #57 and 0.846 MS/m for bucket #7. Ideally, the mean conductivity value of bucket #7 should be lower than bucket #57 since bucket #7 had more operating hours than bucket #57 (resulting in less Aluminum weight percent). As a point of reference, bucket #57 was recoated and operated for 2,000 hours with 219 startups. In contrast, bucket #7 was still an original bucket with 8,286 hours of operation with 670 startups.

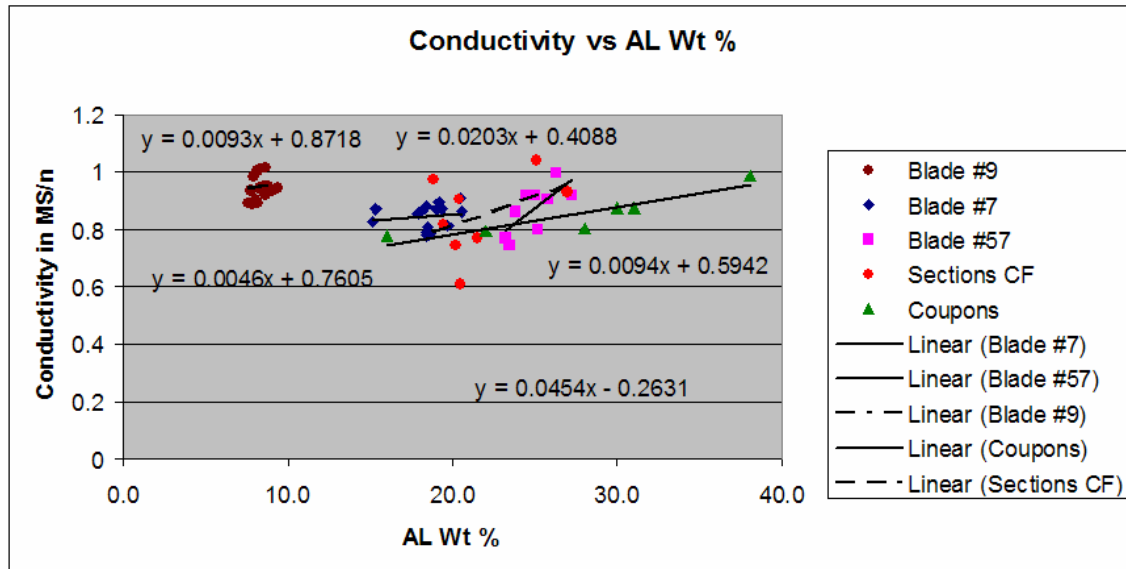
To include additional data points, another GT 33+ coated bucket (#9), a second stage bucket with base-loaded operation of 24,000 hours with 40 startups, was added. The average conductivity value was 0.862 MS/m. Even though this bucket logged more hours, the resultant conductivity value was higher than those values obtained from the three previous buckets. These two additions along with another set obtained from GT 33+ coated coupons fired at 1950° were added to the mix. Besides the as-coated sample, the aged coupons consisted of samples cycled from 250 cycles up to 1938 cycles with no thermal mechanical fatigue cracking. The three new data sets are included to original two data sets and plotted as Figure 6.13.

**Figure 6.13: Comparison of conductivity to Al weight percent of GT 33+ coatings from five different data sets.**

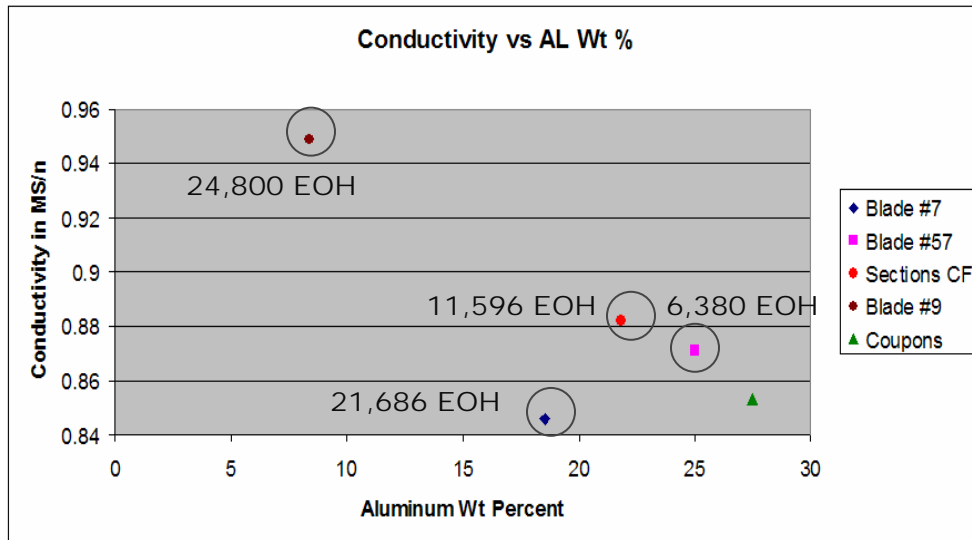
Figure 6.14: Averaged conductivity values to samples with effective number of operating hours

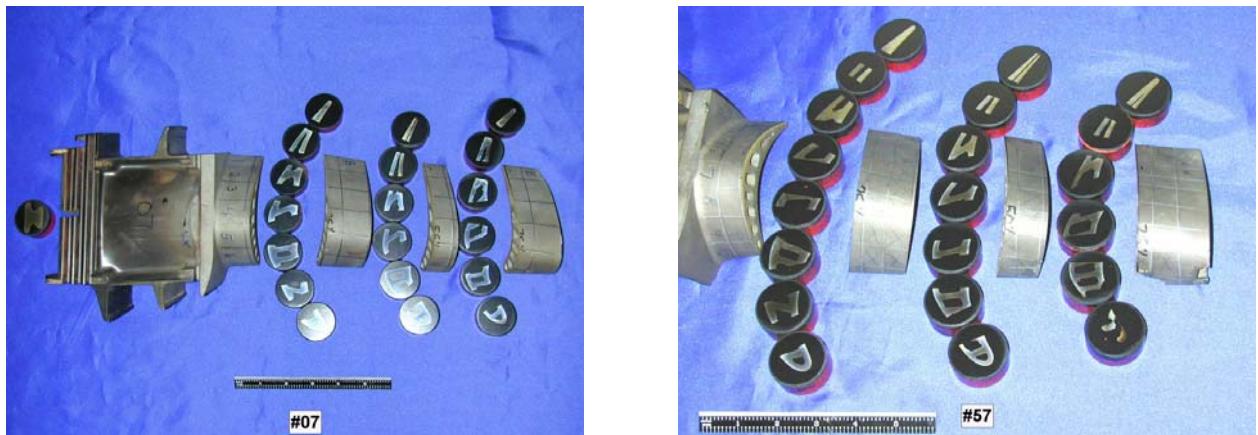
**Figure 7.1: Photographs showing metallurgical sample locations in Bucket 7 and 57**

Examinations of the mounts showed that these buckets had over aluminized NiCoCrAlY coating (GT 33 +). Thermal-mechanical fatigue (TMF) cracks were observed on the convex side of the airfoil near the leading edge of Bucket 7. Majority of the cracks in this bucket were shallow and only a crack in the bucket had extended into the substrate. The deepest crack in Bucket 7 was located on the suction side of the airfoil near the leading edge at the 25% height. Bucket 57 was more severely cracked than Bucket 7. On Bucket 57, TMF cracks were observed on both the convex (suction) and concave (pressure) sides of the airfoil. Several cracks in Bucket 57 were extended into the substrate. Typical morphology of TMF cracks is shown in Figure 7.2.

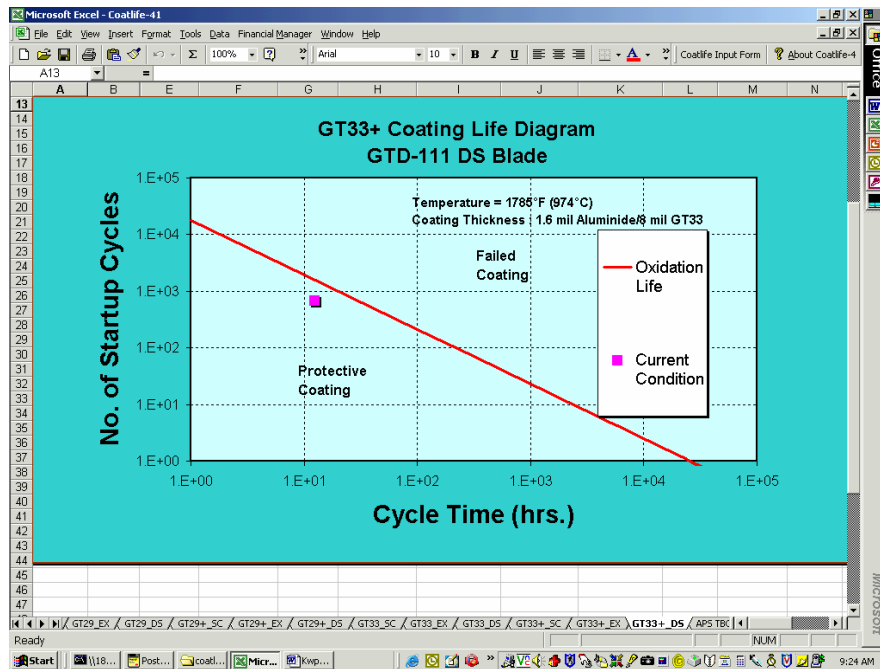
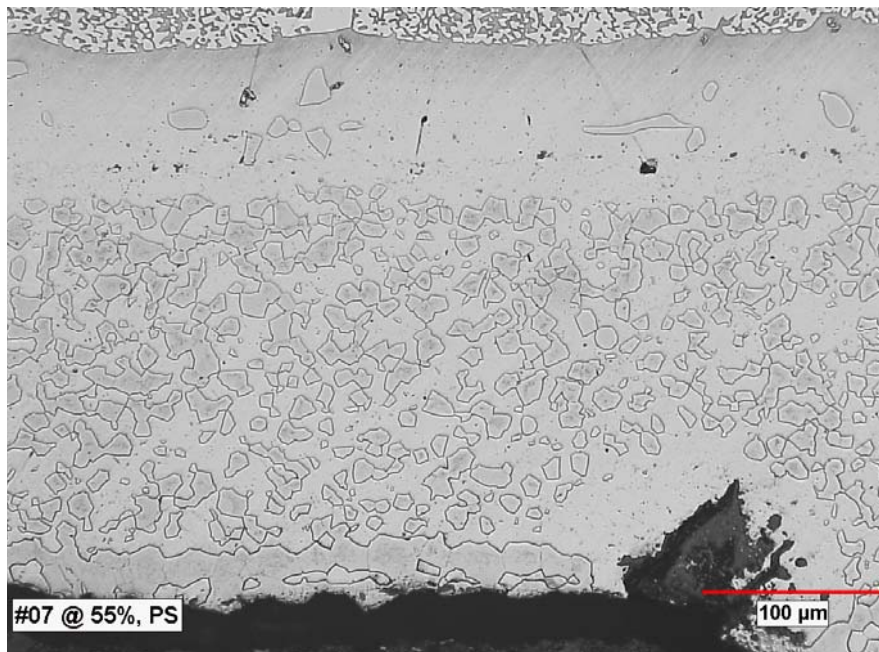
Bucket 7 experienced cracking at the leading edge but not at the trailing edge. Based on the interdiffusion zone width, the local temperature was determined to be 1920°F at the leading edge and 1785°F at the trailing edge. COATLIFE prediction indicates that the oxidation life has been totally consumed (170% life) at the leading edge, but only 47% life has been consumed at the trailing edge. A comparison of COATLIFE prediction and metallographic results of the coating at the leading edge are presented in Figures 7.4 (a) and (b), respectively. The corresponding comparison for results of the trailing edge are presented in Figure 7.5 (a) and (b), respectively. Similar predictions have been made on the other two 7FA machines, which had failure at Bucket C and Bucket 57. A summary of the COATLIFE prediction of oxidation life of CT33+ coating against field data is presented in Table 7.2.

**Figure 7.5: Comparison of COATLIFE prediction of oxidation life for GT33+ against field data for the trailing edge (50% Bucket height) of Bucket 7 in a 7FA machine after 8286 hours and 670 startup cycles: (a) COATLIFE prediction of 42.73% life consumed and a coating life of 1567.9 startup cycles (see Table 3-1), and (b) metallographic section showing the GT33+ coating at the trailing edge (50% bucket height) being protective and in good condition.**

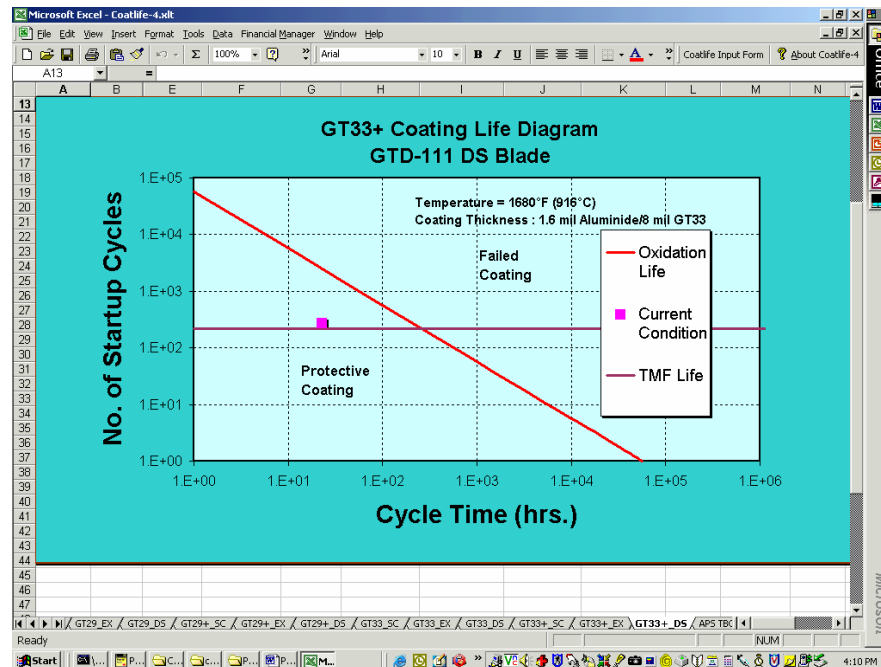
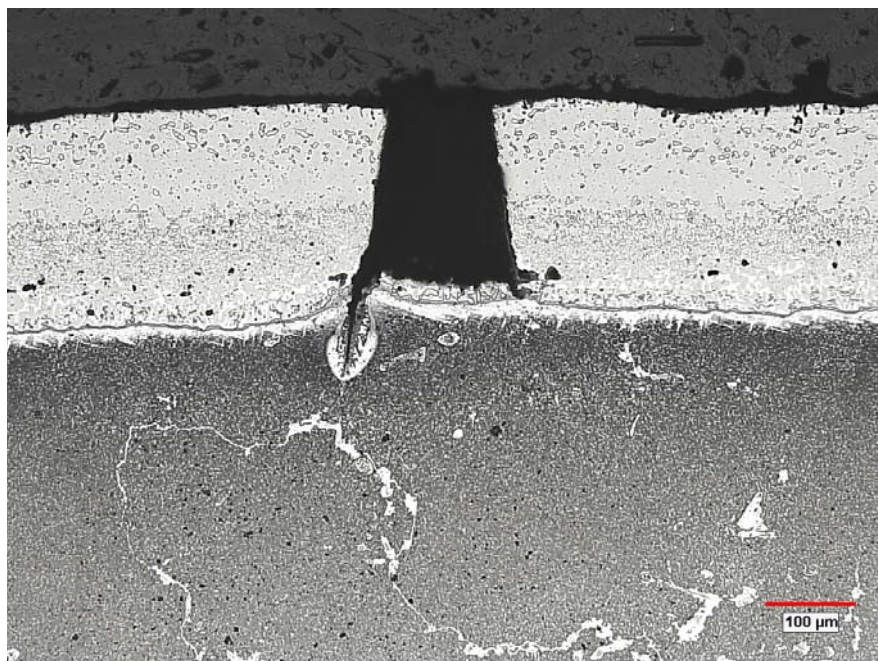
Buckets C, 7, and 57 with GT33+ coating also experienced TMF cracking at different airfoil heights. A summary of the operation history of these buckets is shown in Table 7.2. The local temperature and TMF strain ranges computed by TTI for these locations are also shown in Table 7.2. COATLIFE predictions indicate that the coatings are protective against oxidation, but have exceeded their TMF lives. Figure 7.6 (a) shows the coating life diagram for 7FA Bucket 7 at 25% bucket height. The local temperature was 1660°F and the TMF strain range was 0.8%. After 670 startups at 12.36 hours/cycle (8286 total operating hours), only 14.55% of the oxidation life had been consumed but the coating has exceeded the predicted TMF life (94 cycles) considerably. Metallographic examination of the bucket, Figure 7.6 (b), indicates that the TMF crack had penetrated into the base metal. Figure 7.7 (a) shows the coating life diagram for 7FA Bucket C at 55% bucket height. The local temperature was 1680°F and the TMF strain range was 0.65%. After 272 startups at 22.63 hours/cycle (6156 total operating hours), only 10.81% of the oxidation life had been consumed but the coating had exceeded the predicted TMF life (217.2 cycles). Metallographic examination of the bucket, Figure 7.7 (b), also indicates that the TMF crack had penetrated into the base metal and a small portion of the coating had spalled.

**Figure 7.7: Verification of COATLIFE prediction against field data of GT33+ coated GTD111 DS bucket:**  
(a) COATLIFE prediction of TMF failure at 55% bucket height of Bucket C in a 7FA machine, and (b) metallographic section showing TMF crack penetration into the substrate and exposed bucket due to coating spallation
